PEAK ACCELERATION DEVICE (PAD)

Paul Ibanez, John F. Gray

**ANCO ENGINEERS, INC.
9937 Jefferson Boulevard
Culver City, Calif. 90232-3591**

Final Report for Period April 1985 - December 1986

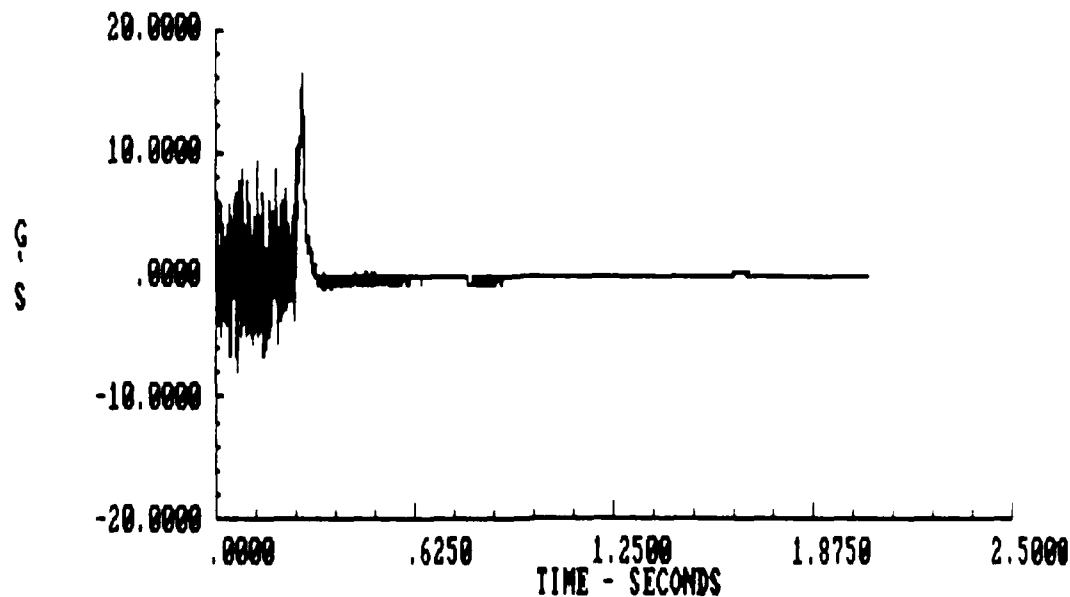
Figure 11. Z-axis impact time history (high g).

CONICAL ISOLATION Z AXIS (HIGH G)
TEST :1 RUN :1
CHANNEL : 2 GRAVITIES
1732 ON TEST FIXTURE

CONICAL ISOLATION Z AXIS (HIGH G)
TEST :1 RUN :1
CHANNEL : 3 GRAVITIES
1714 ON SLED BODY

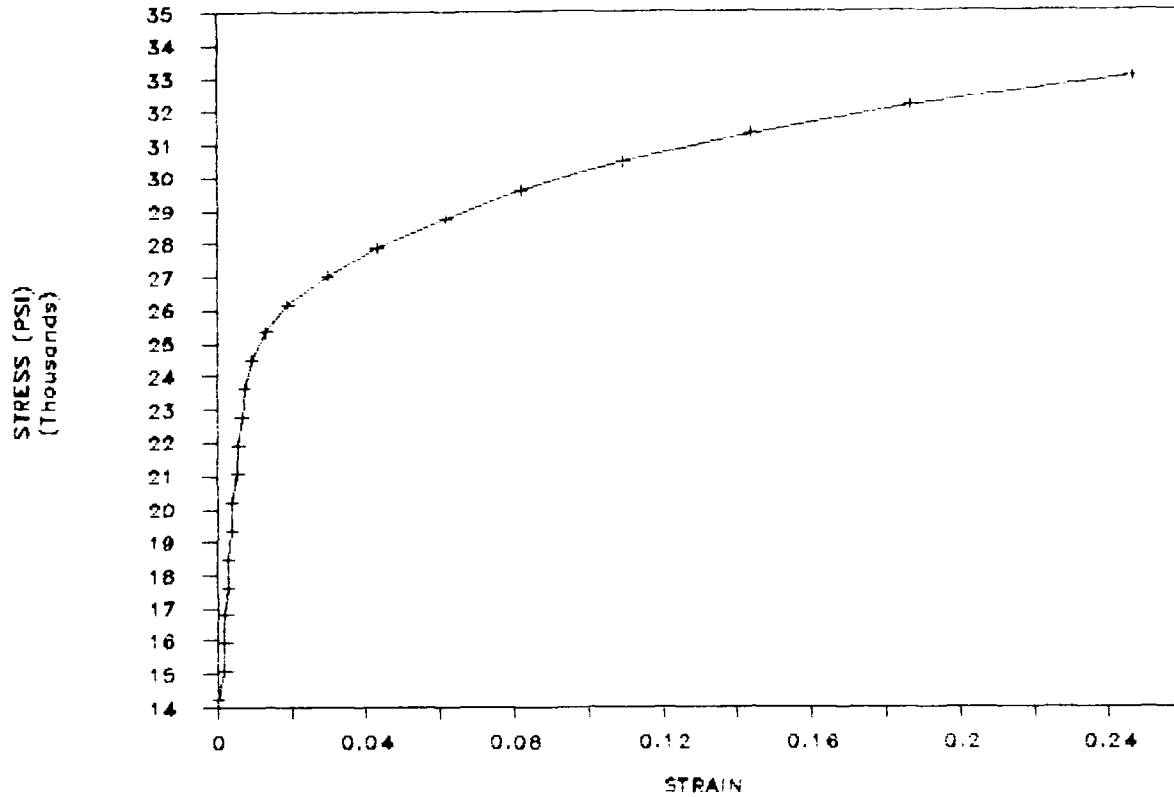
Figure 18. Tensile Test No. 2.

40 GAGE COPPER WIRE (TEST NO. 2)

LOAD (g)	LOAD (lb)	STRESS (psi)	DEFLECTION (DELTA) (in)	STRAIN (in/in)
50.0	0.1102	14234.7	0.0000	0.00000
53.0	0.1168	15088.8	0.1250	0.00187
56.0	0.1235	15942.9	0.1250	0.00187
59.0	0.1301	16797.0	0.1250	0.00187
62.0	0.1367	17651.0	0.1875	0.00280
65.0	0.1433	18505.1	0.1875	0.00280
68.0	0.1499	19359.2	0.2500	0.00373
71.0	0.1565	20213.3	0.2500	0.00373
74.0	0.1631	21067.4	0.3750	0.00560
77.0	0.1698	21921.4	0.3750	0.00560
80.0	0.1764	22775.5	0.4375	0.00653
83.0	0.1830	23629.6	0.5000	0.00746
86.0	0.1896	24483.7	0.6250	0.00933
89.0	0.1962	25337.8	0.8750	0.01306
92.0	0.2028	26191.9	1.2500	0.01866
95.0	0.2094	27045.9	2.0000	0.02985
98.0	0.2160	27900.0	2.8750	0.04291
101.0	0.2227	28754.1	4.1250	0.06157
104.0	0.2293	29608.2	5.5000	0.08209
107.0	0.2359	30462.3	7.3125	0.10914
110.0	0.2425	31316.3	9.6250	0.14366
113.0	0.2491	32170.4	12.5000	0.18657
116.0	0.2557	33024.5	16.5000	0.24627

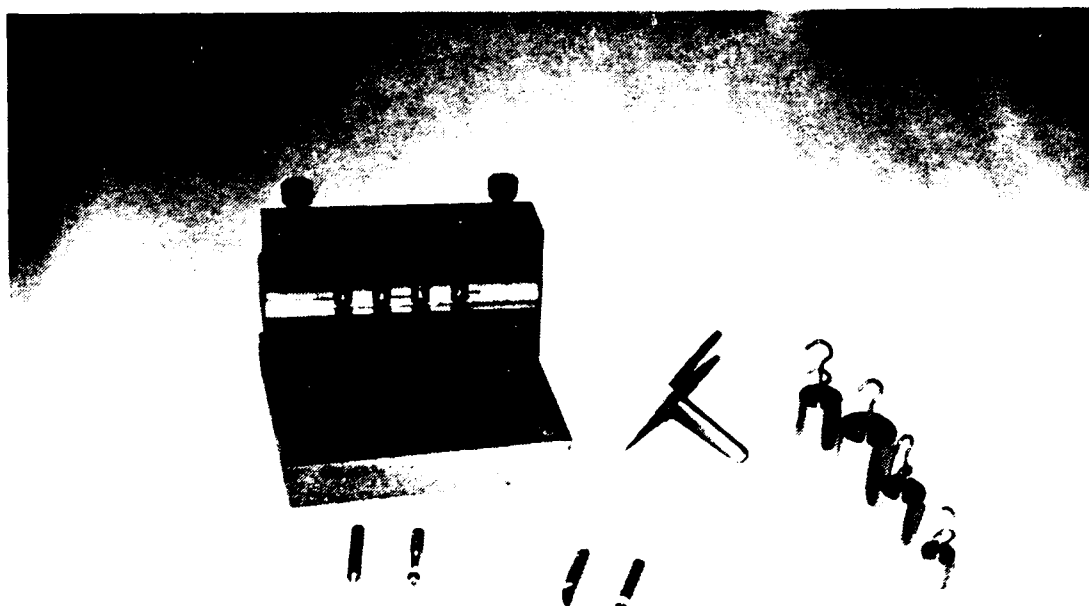
Figure 33. Static test fixture (foils).

During testing, foil samples are clamped between the upper body and the base plate, which are aligned by two registration pins (an important requirement to ensure uniform conditions of loading from test to test). Four cylindrical slugs are used to pierce the foil. They are guided vertically by the body and are loaded with brass weights by means of a special loading platform. The horizontal slot in the body permits viewing of the cylindrical slug during loading so that the process can be stopped once penetration is achieved.

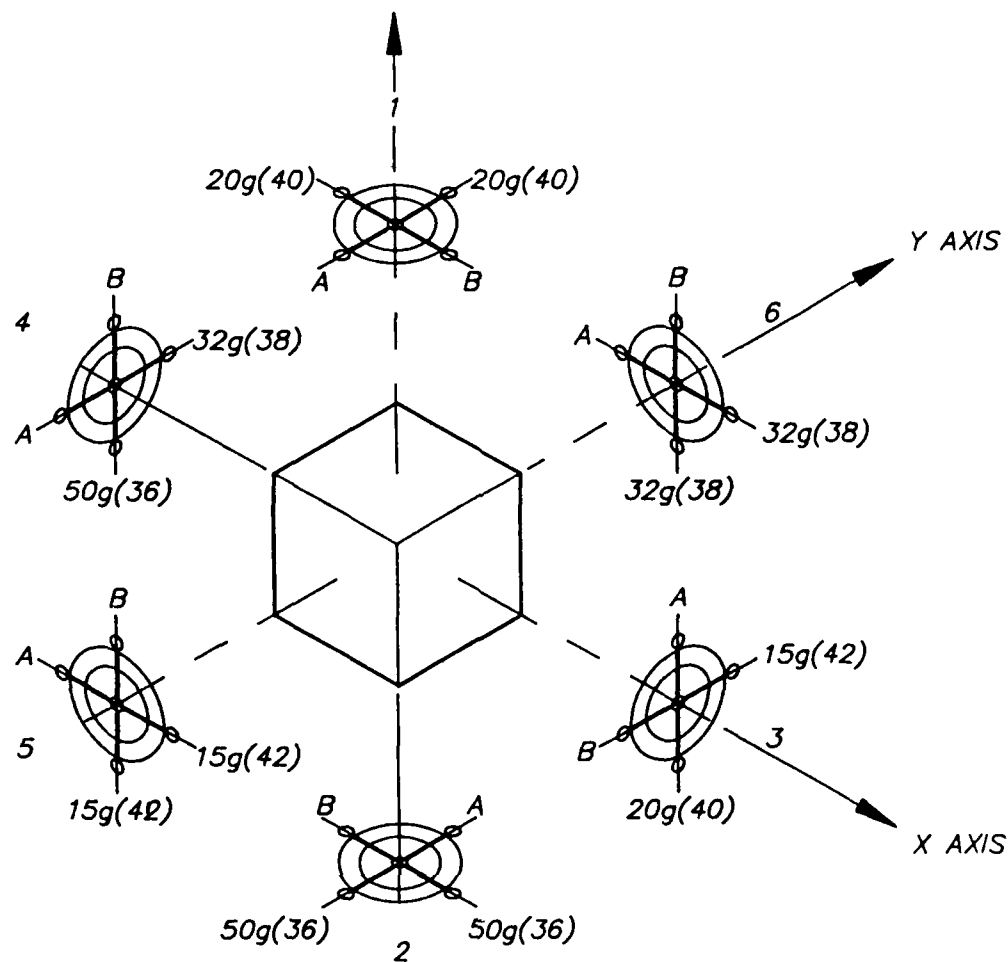
Figure 41. Slug-sensing wire arrangement.

Face	Sensing Wires		Axis	g Range		Percent of Deflection	Estimated Impact Force
	Identity	Gage		Min.	Max.		
F1	A	40	Y	20	32		
	B	40	X	20	32		
F2	A	35	Y	50	125		
	B	35	X	50	125		
F3	A	40	Z	20	32		
	B	42	Y	15	25		
F4	A	38	Y	27	70		
	B	35	Z	50	125		
F5	A	42	X	15	25		
	B	42	Z	15	25		
F6	A	38	X	27	70		
	B	38	Z	27	70

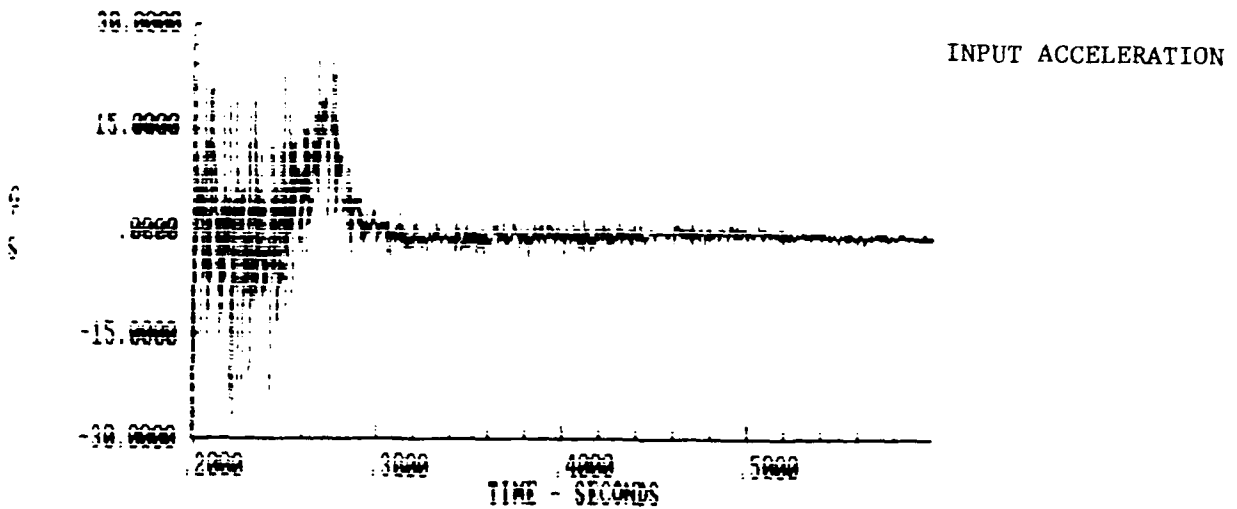
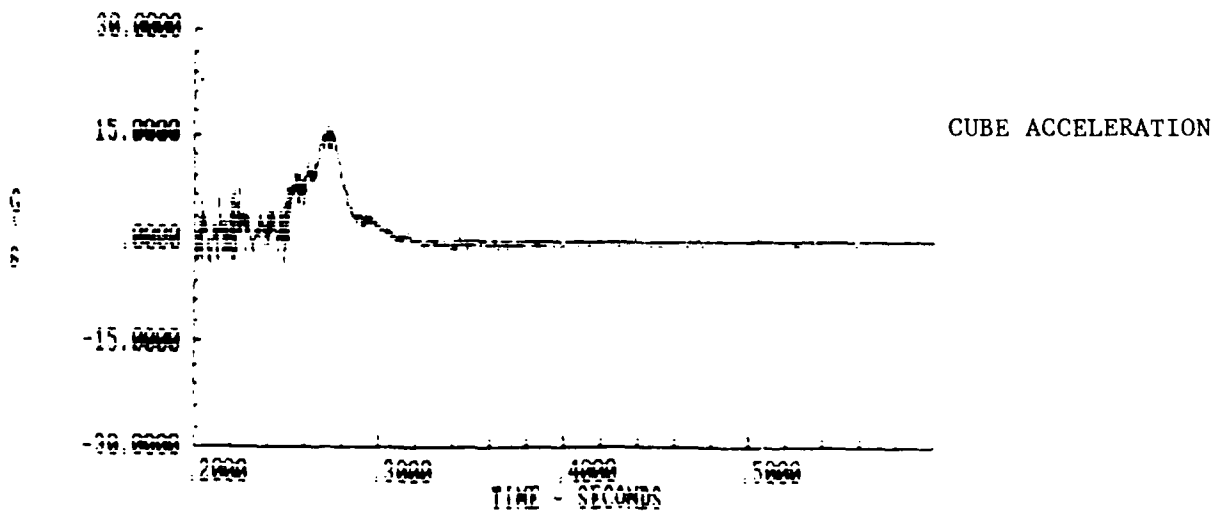
Figure 1.
 Time Histories Showing
 Reduction of High Frequencies

CHECK OF ISOLATION SYSTEM
 TEST 11 MIN 11 RANGE VMIN : -34.6359
 CHANNEL : 2 GRAVITIES VMAX : 26.0964
 1752 ON TEST FEATURE

CHECK OF ISOLATION SYSTEM
 TEST 11 MIN 11 RANGE VMIN : -3.6538
 CHANNEL : 3 GRAVITIES VMAX : 16.3756
 1714 ON SLED BODY

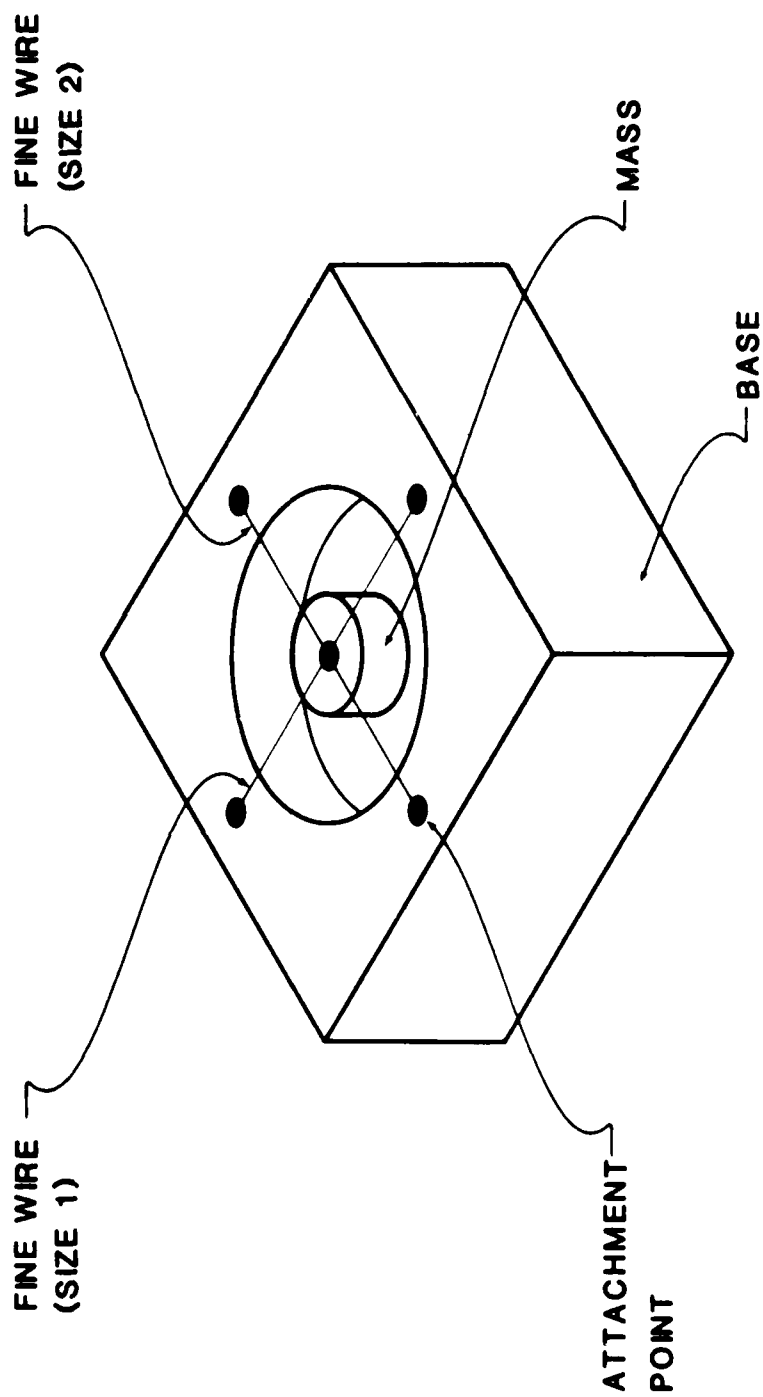
Figure 2. Dual mass wire configuration.

Once the wire/mass system was shown to be feasible we had to consider the packaging on the cube. In order to reduce size we were led to make dual use of each mass via a dual wire system (Figure 2). By attaching two perpendicular wires to
